HELICOPTER SPECIALIST'S FACTUAL REPORT

NTSB No: WPR20LA130

Operator: Southwest Rotors
Aircraft: Bell UH-1H, registration N3276T
Location: Mesa, Arizona
Date: April 24, 2020
Time: 1600 mountain standard time

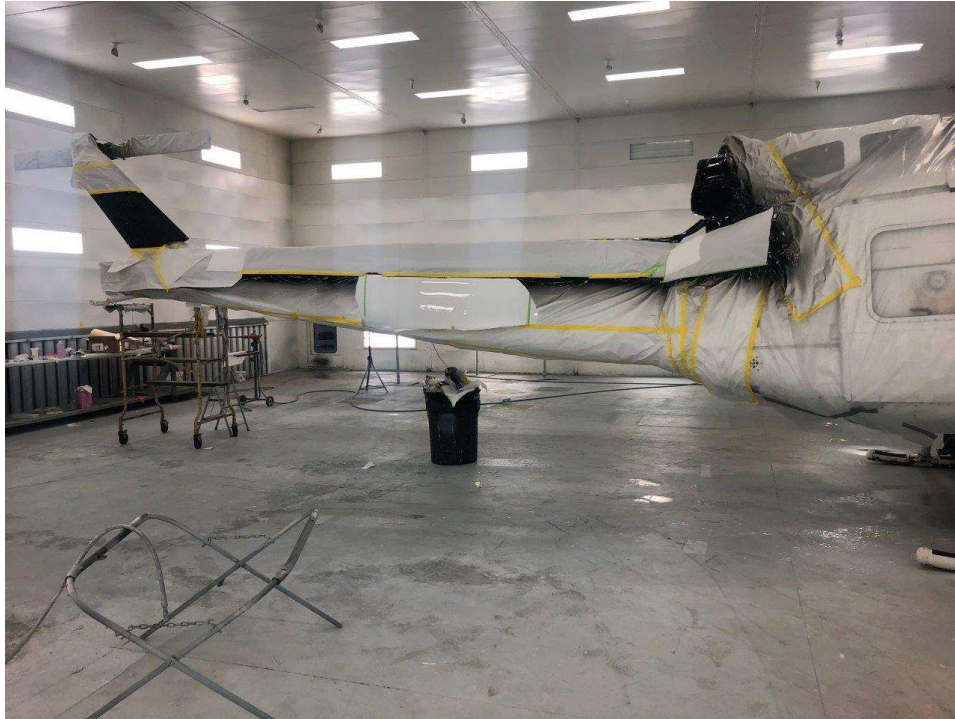
installed on the vertical stabilizer (**Figures 1 and 2**). Various photographs showed the TRGB and tail rotor were masked during painting of the tail boom. The upper portion of the vertical stabilizer, to which the TRGB is mounted, was painted black. The elevators were removed from the tail boom, painted separately, and reinstalled onto the tail boom. Attachment 2 of this report contains the maintenance entry for the painting of the tail boom and elevators.

Figure 1. The accident helicopter during painting of the tail boom. (Courtesy of Arizona Aircraft Painting)

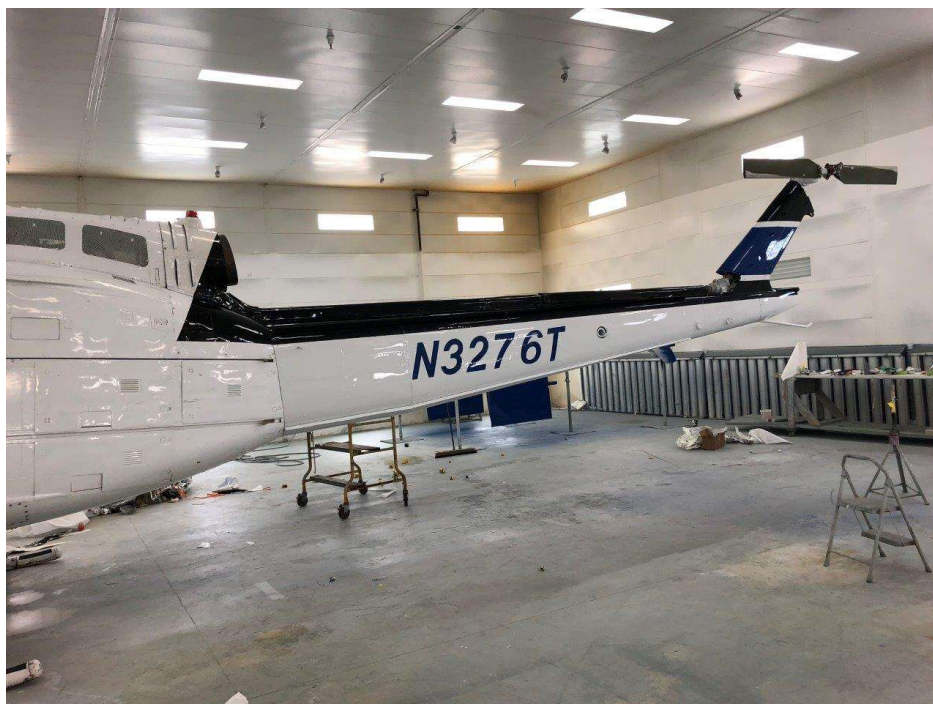
Figure 2. The tail boom after painting was completed. (Courtesy of Arizona Aircraft Painting)
